PHENIX WEEKLY PLANNING

5/17/2012
Don Lynch

TECHNICAL
SUPPORT
2012

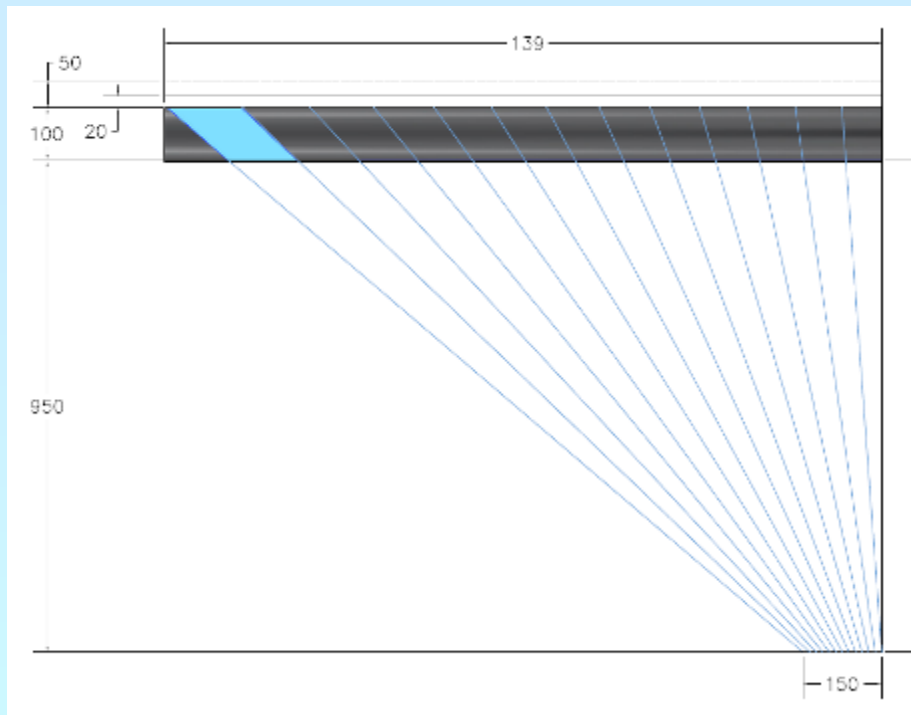
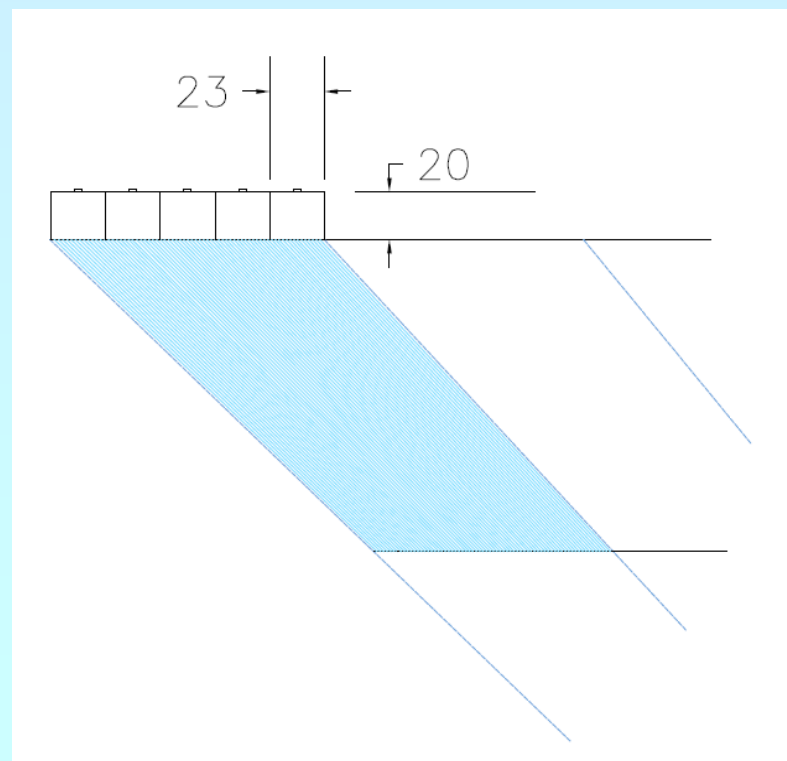
Electromagnetic calorimeter segments using "accordion" shaped scintillators and tungsten plates to optimize detector sampling

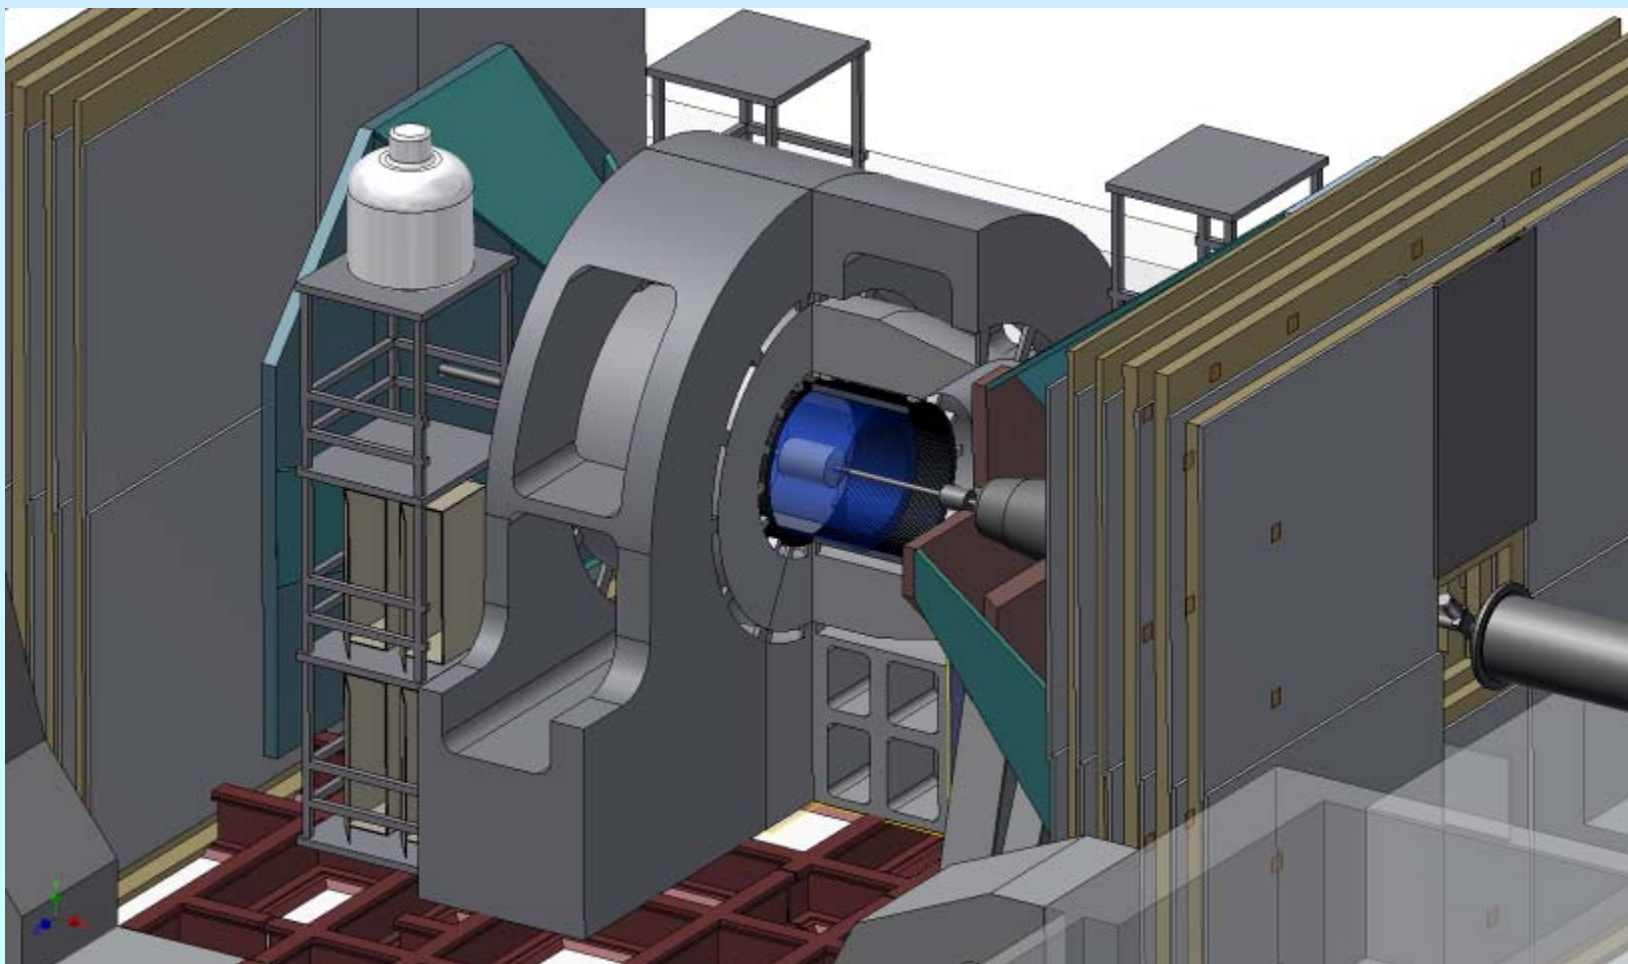
sPHENIX overall assembly, integration and maintenance concept

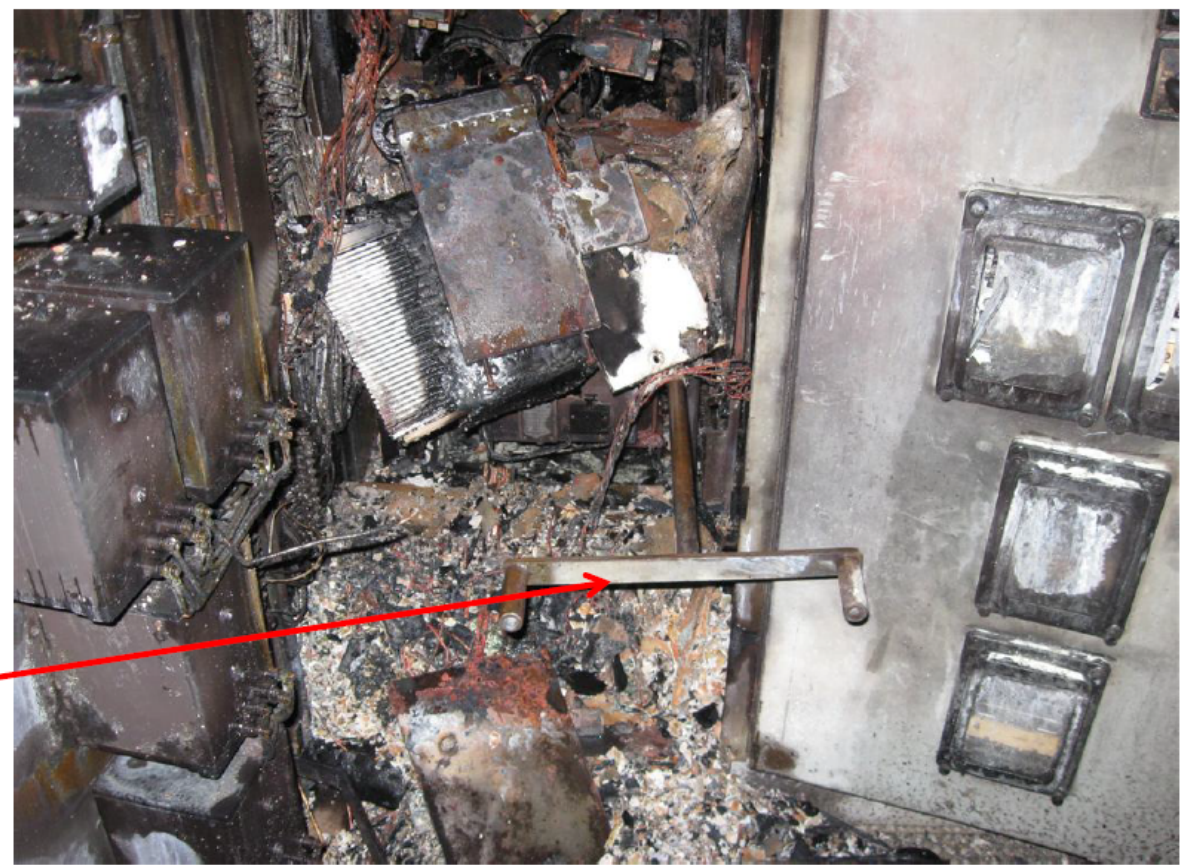
SCG&E Arc Flash Event

5 KV 1200 Amp Breaker

Racking
Handle

- Speculation: Racking breaker in live while the breaker was closed
- **NO** Arc Flash Hazard Analysis
- Incident Energy Unknown
- SCE&G employee hospitalized for a one week period
- Arc Flash PPE saved his life!

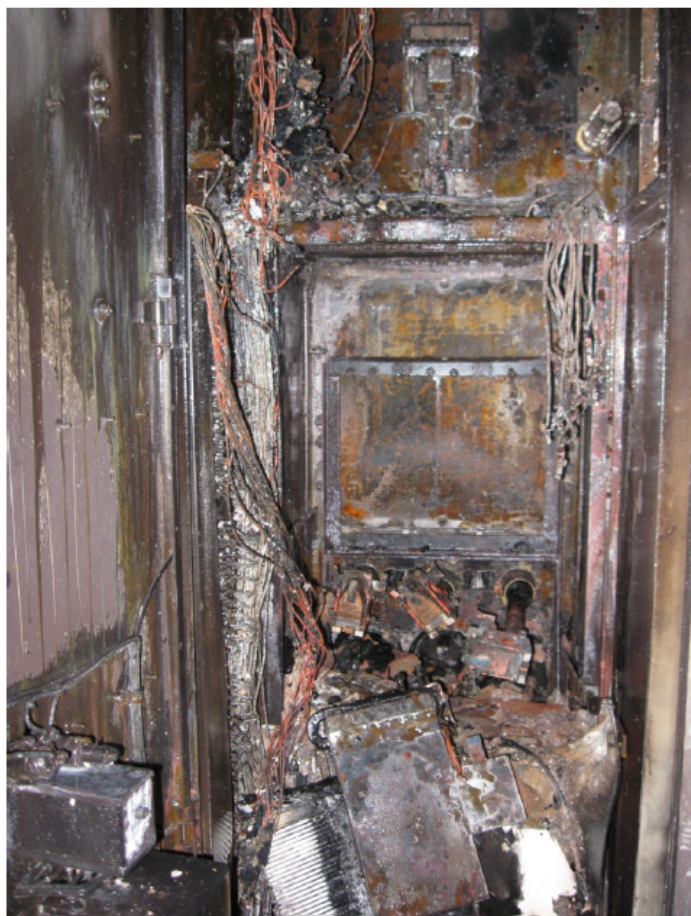
Residual Damage Behind Where the Person was Standing

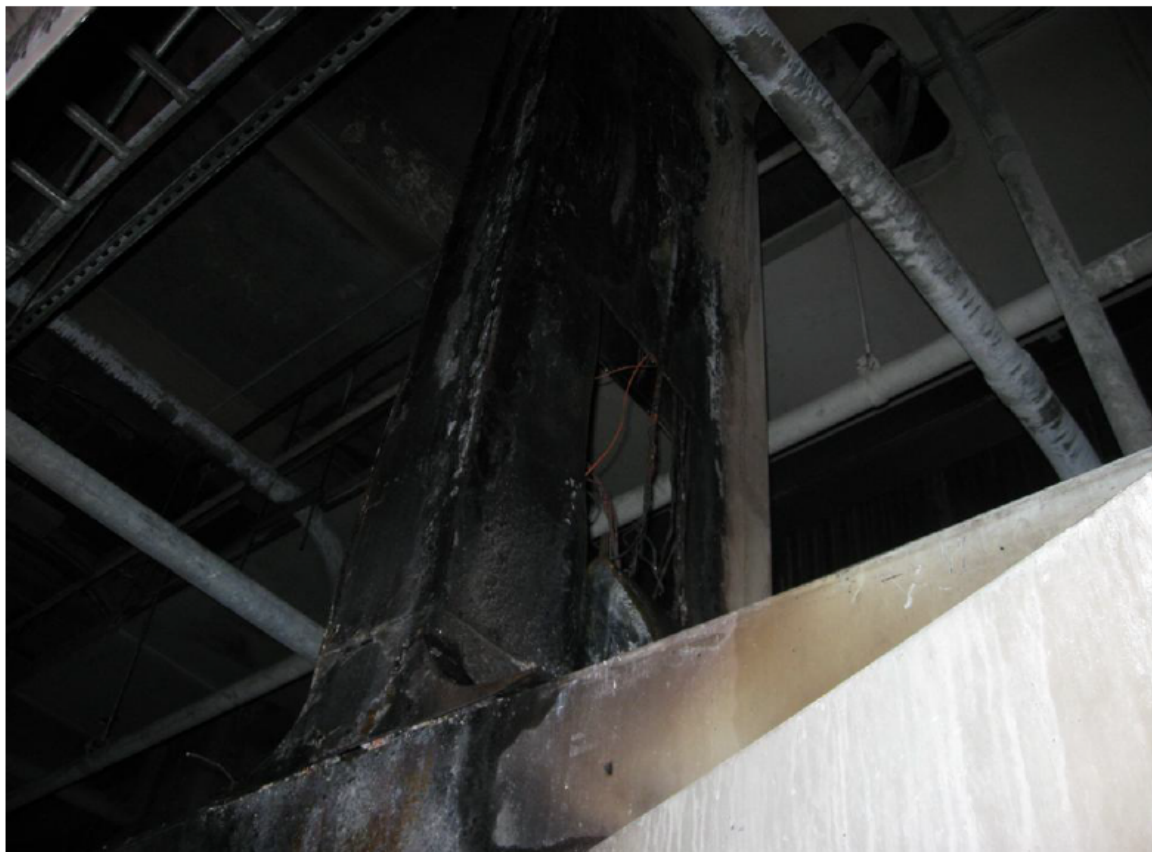
Residual Damage Above the Gear
